Manhole Inspection Summary

Manhole # S43UU_010MH

Insp Date: **2/9/07 10:12 AM**

Location Address: **2826 THE ALAMEDA**

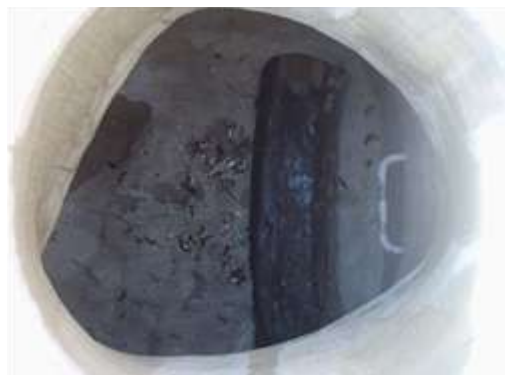
Top View

Infiltration: ☐ None ☒ **Joint** ☐ Cracks ☐ Mortar ☐ Roots ☒ **Wall**

Bench ☒ Exists Material: **Unknown** ☐ Parged ☒ **Debris** (not Condition related)

Adjustment infiltration. Bench debris.

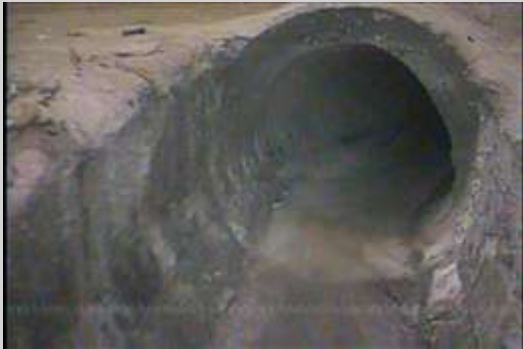
10 in. Circular Gravity Sewer Pipe Out @ 12 O'Clock

Invert Depth: **6.05** (ft.) Flow Characteristics: **Slow**

Infiltration: **Evidence** Pipe Seal Cond: **Unknown**

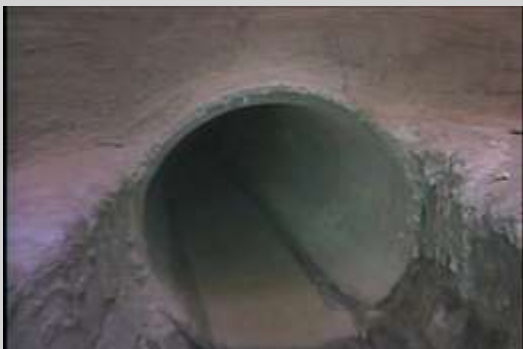
10 in. Circular Gravity Sewer Pipe In @ 6 O'Clock

Invert Depth: **5.97** (ft.) Flow Characteristics: **Slow**

Infiltration: **None** Pipe Seal Cond: **Unknown**
